Revision 4 of Galapagos LSPS Response Corrective Action Plan

1. Galapagos Layout

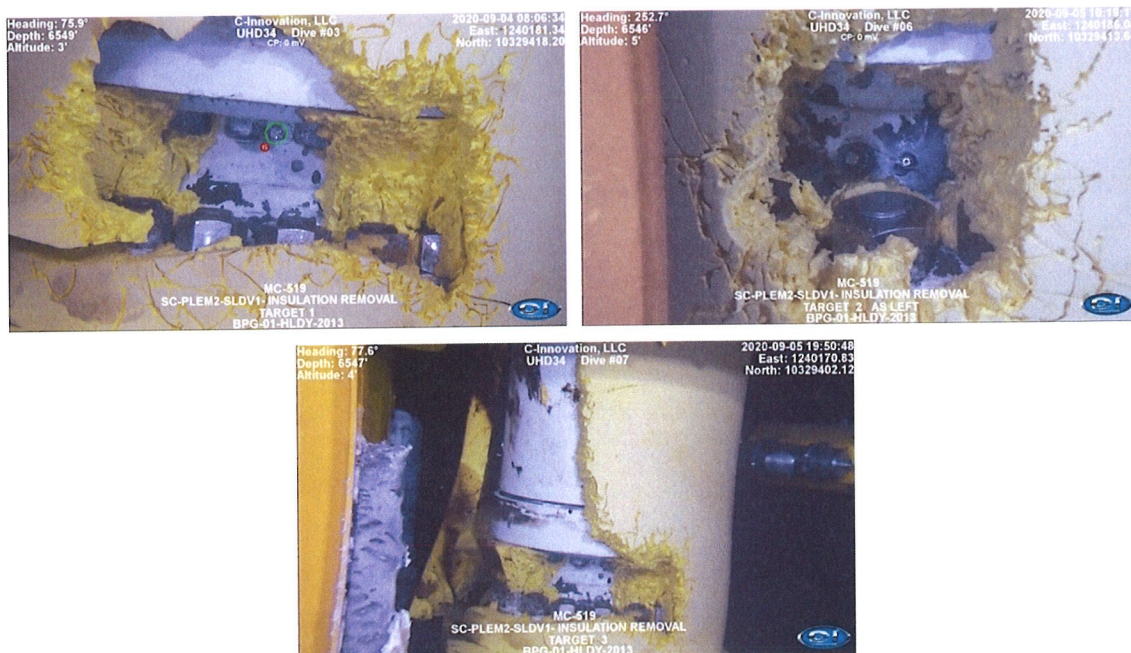
Figure 2: Insulation Removal Results for Grease Port and Disbonded Insulation (Targets 1-3)

3 - 5 September 2020 – Insulation was removed (Figure 2) at grease port locations and other areas where it had disbonded on the SLDV1 valve located at the SC PLEM2. While the insulation removal campaign was unable to identify the leak source, results indicated that additional insulation removal would increase the probability of determining the leak source.

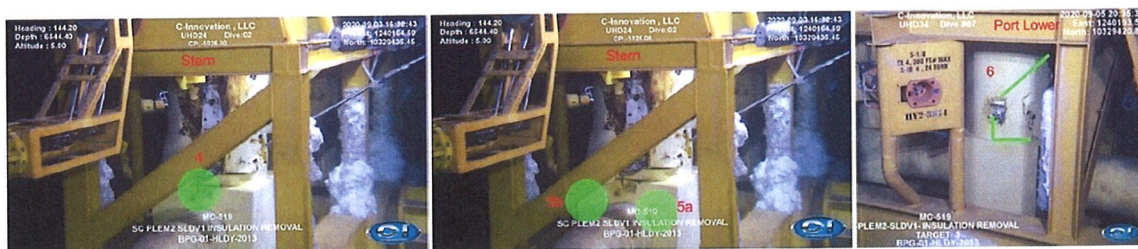
Figure 3: Additional Insulation Removal Targets (Targets 4-6)

25 - 29 September 2020 – Following approval of previous Corrective Action Plan on 14 September 2020, additional insulation was removed (Figures 3 – 5) as attempts to pressurize the SC PLEM2 failed due to lack of communication to the bore.

While additional insulation removal was unable to identify the leak source, visibility at the areas of interest (targets) had been improved and the likelihood of finding the leak source during pressurization has increased.

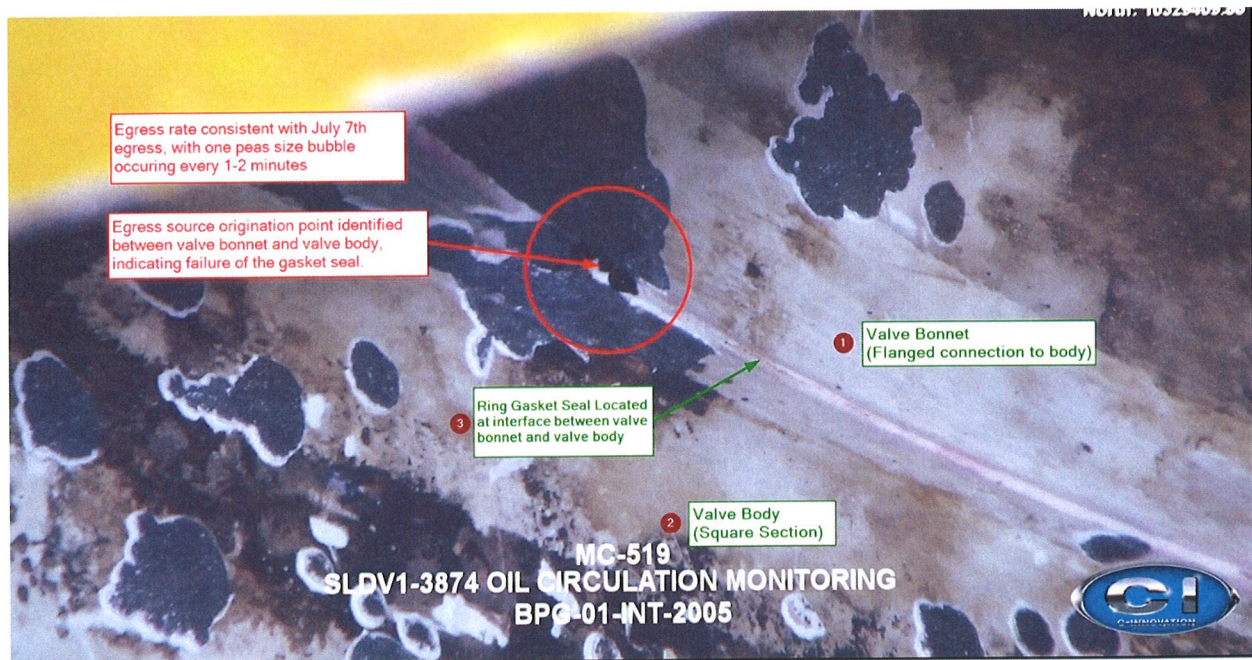
Figure 6: Egress Location

10 – 16 November 2020: During dead oil circulation, the ROV observed dead oil or other fluid egress from the SLDV1 valve located at SC PLEM 2. The egress source origination point was identified as the gasket seal located between the valve bonnet and valve body; see Figure 6. ROV was utilized to collect the egressed volume located under the containment dome and the collected sample bottle returns were sent to Core Labs for testing, [which found no hydrocarbons in the samples](#). No additional egress points were identified during the circulation test.

Egress was witnessed at 14:40 on 15 November following roughly 36 hours of circulation. The egress rate was estimated to be a single pea size bubble (1 cm^3) releasing at an interval of 1 to 2 minutes. The last witnessed release was at 04:23 on 16 November, with the pressure in the SC2 PLEM returning to below hydrostatic conditions at roughly 5:15. The volume of the release is therefore estimated to be between 411 cm^3 (.10 gal) and 875 cm^3 (.23 gallons). No additional bubbles were observed after the pressure was returned to below hydrostatic conditions.
